**Flood Control Project Maintenance  
Levee Inspections**  
**LMA District Cover Sheet**  
**Spring 2017 Levee Inspection Results**

**Reclamation District No. 0900 West Sacramento**

**Spring 2017 Levee Inspection Results**

Waterway			Bank	Unit Miles
Unit No. 01 Sacramento River			Right	7.70
	Spring (March - May)	Summer (June - August)	(September - November) Fall	Winter (December - February)
Unit Maintenance Rating (Fall Only)				
Date of Inspection	5/10/2017 - 5/10/2017			
DWR Inspector	Pavel Kazi			
Accompanied By	Chris Fogel RD 900

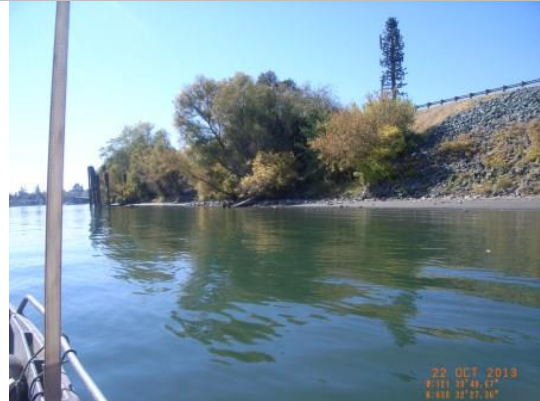
Photo 1 of 1 : SP\_2017\_RD0900\_230\_2\_20170327\_00002.jpg

LM Start	3.27	Rating **	M	Issue No.	2
LM End	3.48	Issue Type +	Ma	Location *	WS
Category	Supplemental			GPS Latitude/Longitude	
				Start	End
Item	2015 USACE Erosion Survey, DRAFT			38.541246 °	38.538689 °
				-121.513561 °	-121.515916 °
DWR ID	DWR_RD0900_01_s_2016_2				
Comment Code					
Inspector Comment					
2008 - Erosion into levee toe. Over steepened levee slope, worst at the upstream end. 2009 - Near vertical banks from rotational slumping, hidden by vegetation. 2010 - Boat sinking more, may be causing eddy scour around it. Difficult to see the vertical slumps due to dense vegetation. 2011 - Minor new erosion at the toe. The paddleboat that was sitting at this site for years has been removed. 2012 - Site extended upstream due to additional erosion. 2015: No observed changes. [2015 Site ID: SAC_55-7_R]

USACE 2013 Photo #1

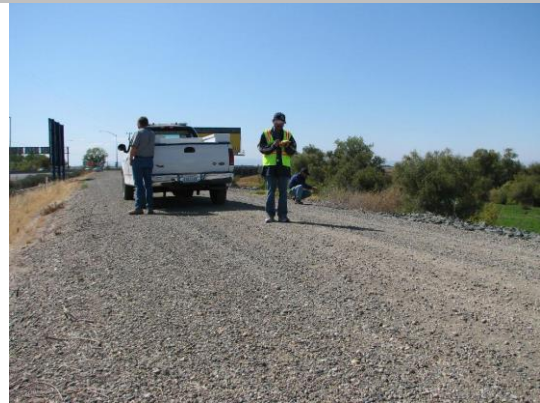
Photo 1 of 3 : UCIP\_SP\_2017\_41825\_72725.jpg

View of levee crown near marker.

Comment Code						
Inspector Comment						
FS_ID:41825 DS_ID:17862 EP_NO: 2444 Repair Type: Non-Urgent Crossing Status: Indicator Found UCIP Comments: Records show 3 gas lines in general area--unable to confirm alignment and status of crossing. Markers visible in general area are for Kinder Morgan and not the owner listed on permit. Need to contact owner to clarify if crossing is still present and if so determine status of crossing. Need date of last inspection and confirmation that crossing is still in operable condition. FIELD_STRUCT_DESC: 16-inch high pressure steel gas line through the levee 3.0 feet below the crown. (Permit No. 2444 & 2893 - PG&E) FS Date: 10/5/2009

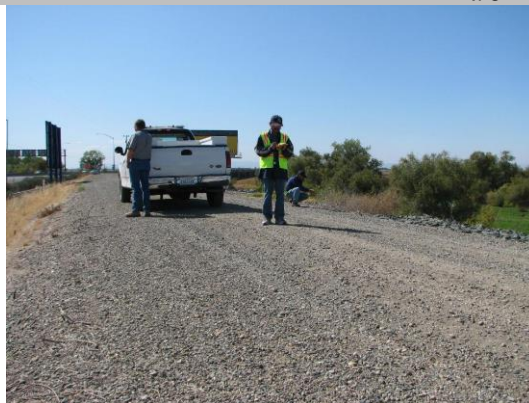
Photo 1 of 3 : UCIP\_SP\_2017\_41826\_72722.jpg

Comment Code					
Inspector Comment					
FS_ID:41826 DS_ID:17874 EP_NO: 17739 Repair Type: Non-Urgent Crossing Status: Indicator Found UCIP Comments: Records show 3 gas lines in general area--unable to confirm alignment and status of crossing. Markers visible in general area are for Kinder Morgan and not the owner listed on permit. Need to contact owner to clarify if crossing is still present and if so determine status of crossing. Need date of last inspection and confirmation that crossing is still in operable condition. FIELD_STRUCT_DESC: To install a 20-inch diameter petroleum pipeline across and under (bored) Willow Slough and its west levee, across (trenched) the Yolo bypass, and across and under (bored) Toe drain and east levee. Permit No. 17739. FS Date: 10/5/2009

View of levee crown near marker.

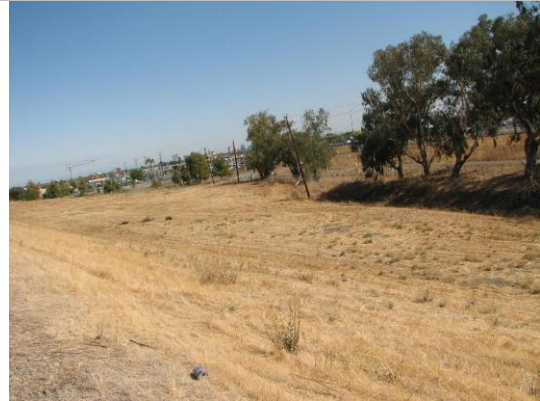
Photo 3 of 3 : UCIP\_SP\_2017\_41826\_72720.jpg

Comment Code						
Inspector Comment						
FS_ID:41826						
DS_ID:17874						
EP_NO: 17739						
Repair Type: Non-Urgent						
Crossing Status: Indicator Found						
UCIP Comments: Records show 3 gas lines in general area--unable to confirm alignment and status of crossing. Markers visible in general area are for Kinder Morgan and not the owner listed on permit. Need to contact owner to clarify if crossing is still present and if so determine status of crossing. Need date of last inspection and confirmation that crossing is still in operable condition.						
FIELD_STRUCT_DESC: To install a 20-inch diameter petroleum pipeline across and under (bored) Willow Slough and its west levee, across (trenched) the Yolo bypass, and across and under (bored) Toe drain and east levee. Permit No. 17739.						
FS Date: 10/5/2009

View of additional marker visible on landward side.

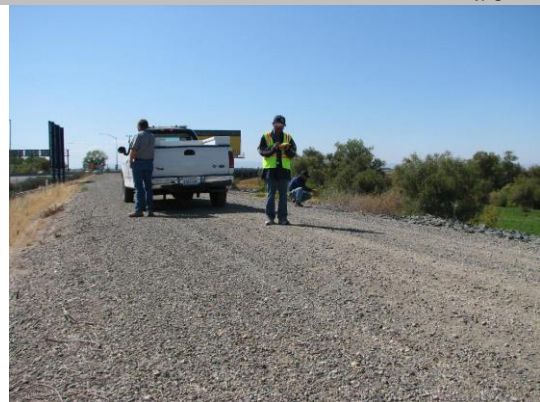
Photo 1 of 3 : UCIP\_SP\_2017\_41824\_72728.jpg

Comment Code					
Inspector Comment					
FS_ID:41824 DS_ID:17861 EP_NO: 11539 Repair Type: Non-Urgent Crossing Status: Indicator Found UCIP Comments: Records show 3 gas lines in general area--unable to confirm alignment and status of crossing. Markers visible in general area are for Kinder Morgan and not the owner listed on permit. Need to contact owner to clarify if crossing is still present and if so determine status of crossing. Need date of last inspection and confirmation that crossing is still in operable condition. FIELD_STRUCT_DESC: 16-inch steel gas pipeline through the levee 3.5 feet below the crown. (Pending 1/77, App. No. 11539 - PG&E). FS Date: 10/5/2009

View of levee crown near marker visible on landward shoulder.

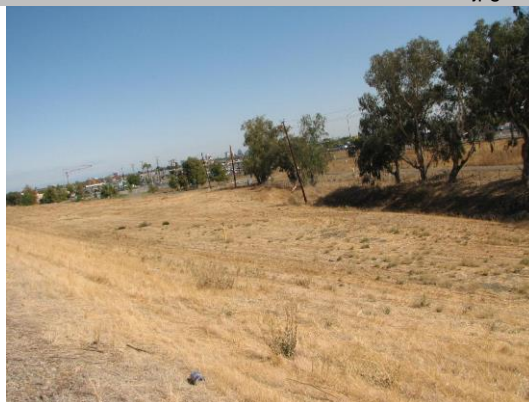
Photo 3 of 3 : UCIP\_SP\_2017\_41824\_72726.jpg

Comment Code					
Inspector Comment					
FS_ID:41824 DS_ID:17861 EP_NO: 11539 Repair Type: Non-Urgent Crossing Status: Indicator Found UCIP Comments: Records show 3 gas lines in general area--unable to confirm alignment and status of crossing. Markers visible in general area are for Kinder Morgan and not the owner listed on permit. Need to contact owner to clarify if crossing is still present and if so determine status of crossing. Need date of last inspection and confirmation that crossing is still in operable condition. FIELD_STRUCT_DESC: 16-inch steel gas pipeline through the levee 3.5 feet below the crown. (Pending 1/77, App. No. 11539 - PG&E). FS Date: 10/5/2009

Marker of petroleum pipeline unable to confirm permit--there are 3 gas line in desk study records for gas line but none for Kinder Morgan.

View of additional marker visible on landward side.

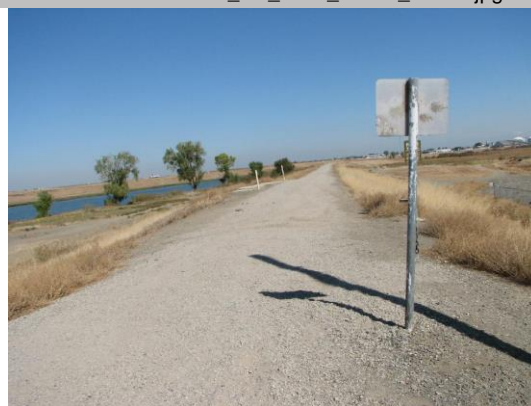
Photo 1 of 3 : UCIP\_SP\_2017\_37770\_68626.jpg

LM Start	3.23	Rating **	M	Issue No.	60
LM End	3.23	Issue Type +	En	Location *	LS
Category	Supplemental			GPS Latitude/Longitude	
				Start	End
Item	DWR UCIP Field Study			38.541353 °	38.541353 °
				-121.582202 °	-121.582202 °
DWR ID					
Comment Code					
Inspector Comment					
FS_ID:37770 DS_ID:17885 EP_NO: 17070 Repair Type: Non-Urgent Crossing Status: Found UCIP Comments: Dense vegetation limits the inspector's visibility to identify signs of pipe failure (leaks) along the slope. Recommend removing vegetation along pipe alignment to conduct proper inspection of structure. FIELD_STRUCT_DESC: 1 of 5. 30-inch-diameter steel storm drain pipelines through the left (east) bank levee and a discharge structure in the floodway of the Sacramento River Deep Water Ship Channel. (Permit No. 17070-2000). The pipe depth is 2.0 ft. below the crown. FS Date: 10/5/2009

View of levee crown at crossing.

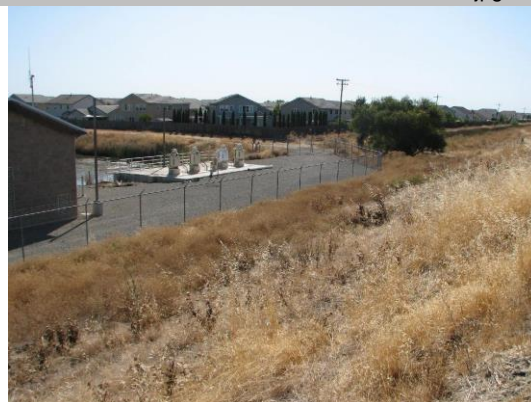
Photo 2 of 3 : UCIP\_SP\_2017\_37770\_68625.jpg

Pump station located on waterward side.

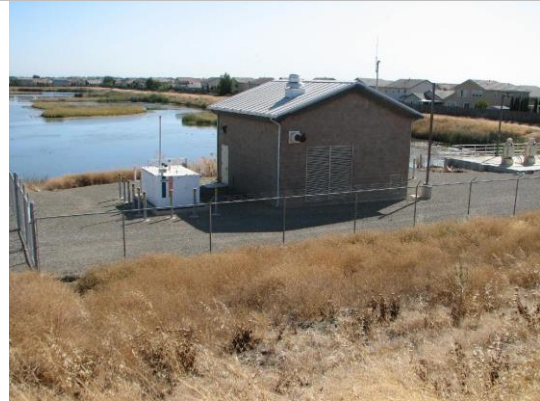
Photo 3 of 3 : UCIP\_SP\_2017\_37770\_68624.jpg

LM Start	3.23	Rating **	M	Issue No.	60 (cont)	
LM End	3.23	Issue Type +	En	Location *	LS	
Category	Supplemental			GPS Latitude/Longitude		
				Start	End	
Item	DWR UCIP Field Study			38.541353 °	38.541353 °	
				-121.582202 °	-121.582202 °	
DWR ID						
Comment Code						
Inspector Comment						
FS_ID:37770 DS_ID:17885 EP_NO: 17070 Repair Type: Non-Urgent Crossing Status: Found UCIP Comments: Dense vegetation limits the inspector's visibility to identify signs of pipe failure (leaks) along the slope. Recommend removing vegetation along pipe alignment to conduct proper inspection of structure. FIELD_STRUCT_DESC: 1 of 5. 30-inch-diameter steel storm drain pipelines through the left (east) bank levee and a discharge structure in the floodway of the Sacramento River Deep Water Ship Channel. (Permit No. 17070-2000). The pipe depth is 2.0 ft. below the crown. FS Date: 10/5/2009

House structure located on waterward side.

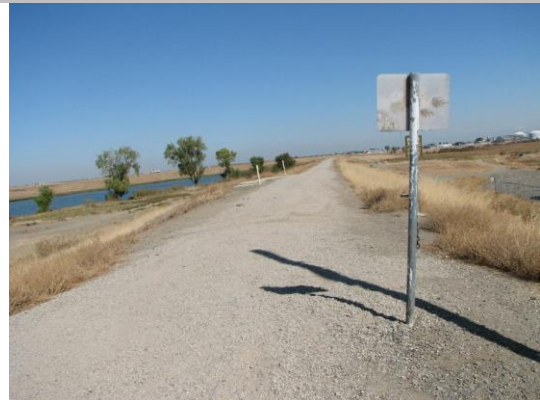
Photo 1 of 3 : UCIP\_SP\_2017\_37766\_68620.jpg

LM Start	3.23	Rating **	M	Issue No.	61
LM End	3.23	Issue Type +	En	Location *	LS
Category	Supplemental			GPS Latitude/Longitude	
				Start	End
Item	DWR UCIP Field Study			38.541330 °	38.541330 °
				-121.582201 °	-121.582201 °
DWR ID					
Comment Code					
Inspector Comment					
FS_ID:37766 DS_ID:17876 EP_NO: 17070 Repair Type: Non-Urgent Crossing Status: Found UCIP Comments: Dense vegetation limits the inspector's visibility to identify signs of pipe failure (leaks) along the slope. Recommend removing vegetation along pipe alignment to conduct proper inspection of structure. FIELD_STRUCT_DESC: 2 of 5. 30-inch-diameter steel storm drain pipelines through the left (east) bank levee and a discharge structure in the floodway of the Sacramento River Deep Water Ship Channel. (Permit No. 17070-2000). The pipe depth is 2.0 ft. below the crown. FS Date: 10/5/2009

View of levee crown at crossing.

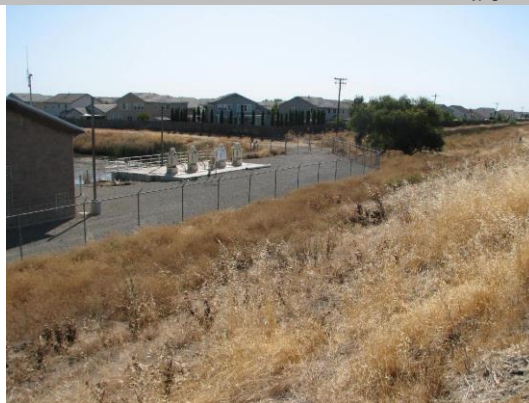
Photo 2 of 3 : UCIP\_SP\_2017\_37766\_68619.jpg

Concrete pad with pumps located on landward side.

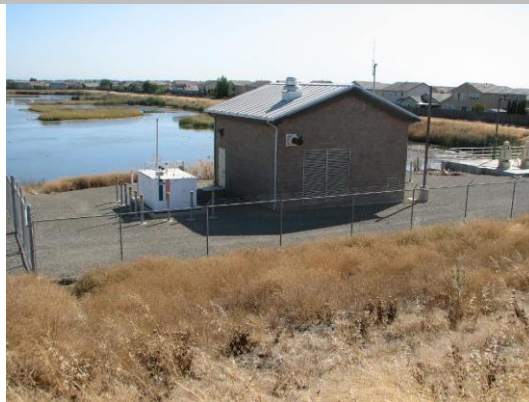
Photo 3 of 3 : UCIP\_SP\_2017\_37766\_68618.jpg

House structure located on landward side.

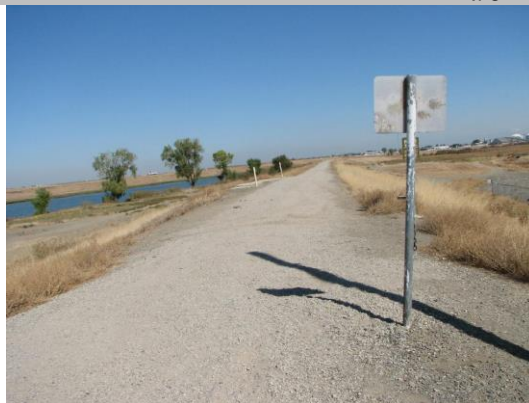
Photo 1 of 3 : UCIP\_SP\_2017\_37778\_68650.jpg

LM Start	3.23	Rating **	M	Issue No.	62
LM End	3.23	Issue Type +	En	Location *	LS
Category	Supplemental			GPS Latitude/Longitude	
				Start	End
Item	DWR UCIP Field Study			38.541311 °	38.541311 °
				-121.582201 °	-121.582201 °
DWR ID					
Comment Code					
Inspector Comment					
FS_ID:37778 DS_ID:17888 EP_NO: 17070 Repair Type: Non-Urgent Crossing Status: Found UCIP Comments: Dense vegetation limits the inspector's visibility to identify signs of pipe failure (leaks) along the slope. Recommend removing vegetation along pipe alignment to conduct proper inspection of structure. FIELD_STRUCT_DESC: 3 of 5. 12-inch-diameter steel storm drain pipelines through the left (east) bank levee and a discharge structure in the floodway of the Sacramento River Deep Water Ship Channel. (Permit No. 17070-2000). The pipe depth is 2.0 ft. below the crown. FS Date: 10/5/2009

View of levee crown at crossing.

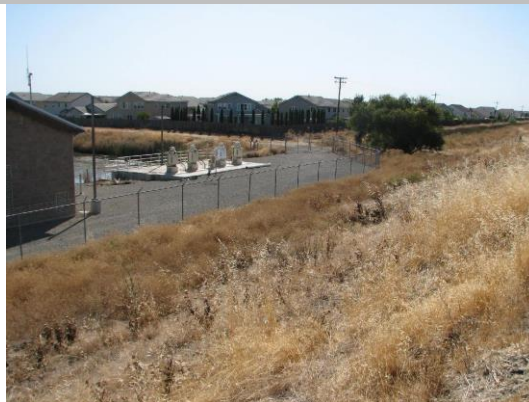
Photo 2 of 3 : UCIP\_SP\_2017\_37778\_68649.jpg

Pump station located on landward side.

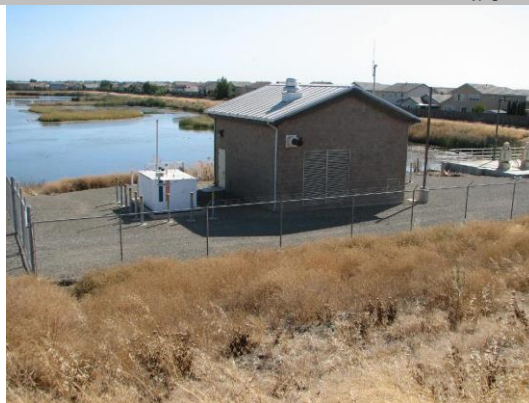
Photo 3 of 3 : UCIP\_SP\_2017\_37778\_68648.jpg

Comment Code						
Inspector Comment						
FS_ID:37778						
DS_ID:17888						
EP_NO: 17070						
Repair Type: Non-Urgent						
Crossing Status: Found						
UCIP Comments: Dense vegetation limits the inspector's visibility to identify signs of pipe failure (leaks) along the slope. Recommend removing vegetation along pipe alignment to conduct proper inspection of structure.						
FIELD_STRUCT_DESC: 3 of 5. 12-inch-diameter steel storm drain pipelines through the left (east) bank levee and a discharge structure in the floodway of the Sacramento River Deep Water Ship Channel. (Permit No. 17070-2000). The pipe depth is 2.0 ft. below the crown.						
FS Date: 10/5/2009

House structure located on landward side.

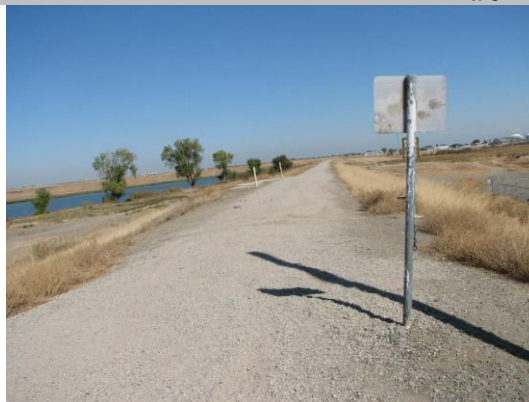
Photo 1 of 3 : UCIP\_SP\_2017\_37780\_68662.jpg

LM Start	3.24	Rating **	M	Issue No.	63
LM End	3.24	Issue Type +	En	Location *	LS
Category	Supplemental			GPS Latitude/Longitude	
				Start	End
Item	DWR UCIP Field Study			38.541290 °	38.541290 °
				-121.582201 °	-121.582201 °
DWR ID					
Comment Code					
Inspector Comment					
FS_ID:37780 DS_ID:17887 EP_NO: 17070 Repair Type: Non-Urgent Crossing Status: Found UCIP Comments: Dense vegetation limits the inspector's visibility to identify signs of pipe failure (leaks) along the slope. Recommend removing vegetation along pipe alignment to conduct proper inspection of structure. FIELD_STRUCT_DESC: 4 of 5. 30-inch-diameter steel storm drain pipelines through the left (east) bank levee and a discharge structure in the floodway of the Sacramento River Deep Water Ship Channel. (Permit No. 17070-2000). The pipe depth is 2.0 ft. below the crown. FS Date: 10/5/2009

View of levee crown at crossing.

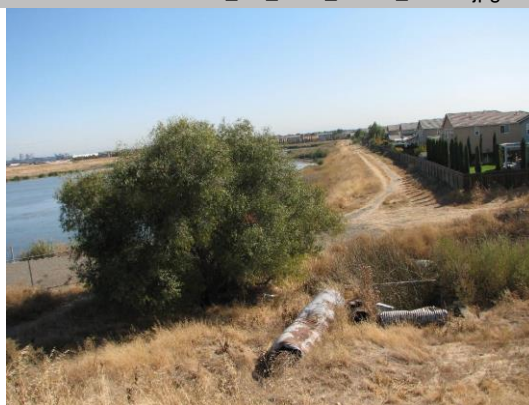
Photo 1 of 3 : UCIP\_SP\_2017\_37785\_68693.jpg

LM Start	3.26	Rating **	M	Issue No.	65
LM End	3.26	Issue Type +	En	Location *	LS
Category	Supplemental			GPS Latitude/Longitude	
				Start	End
Item	DWR UCIP Field Study			38.540959 °	38.540959 °
				-121.582224 °	-121.582224 °
DWR ID					
Comment Code					
Inspector Comment					
FS_ID:37785					
DS_ID:17856					
EP_NO: 2721A					
Repair Type: Non-Urgent					
Crossing Status: Found					
UCIP Comments: Need to contact owner--crossing appears to no longer be in use. Abandoned pipe sections visible on landward side and damage to pump station on waterward side.					
FIELD_STRUCT_DESC: 30-inch corrugated metal pipe through the levee 3.0 feet below crown. Pump house and siphon breaker on the waterward slope. (App. No. 2721A - R.D. No. 900) (Station 2)					
FS Date: 10/5/2009

View of pipe sections visible on landward side.

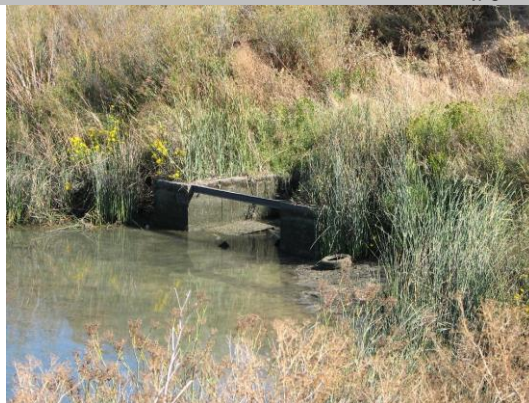
Photo 2 of 3 : UCIP\_SP\_2017\_37785\_68692.jpg

Concrete outlet visible on waterward side.

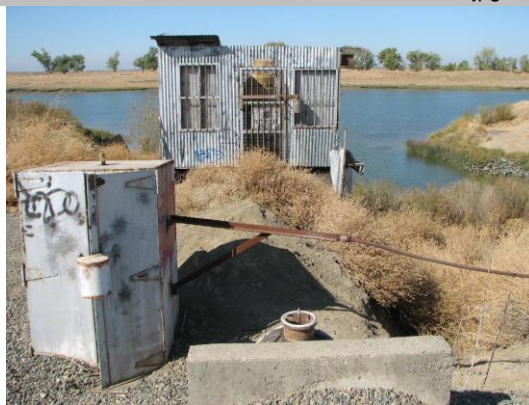
Photo 3 of 3 : UCIP\_SP\_2017\_37785\_68691.jpg

View of pump house visible on waterward side.

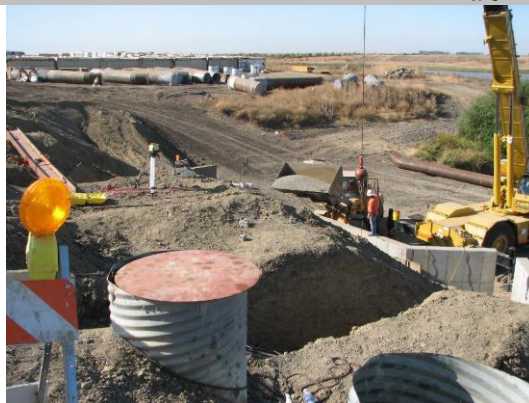
Photo 1 of 3 : UCIP\_SP\_2017\_37890\_68941.jpg

Construction of structures in Oct-2009, photo 1 of 3.

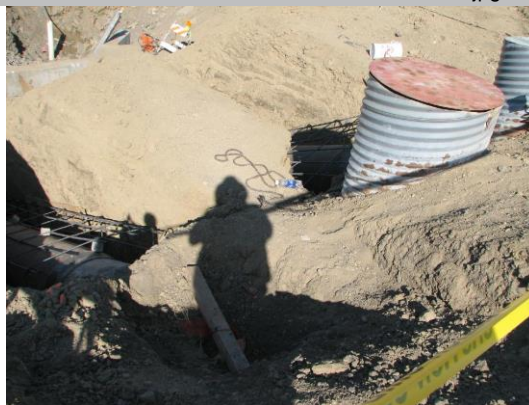
Photo 2 of 3 : UCIP\_SP\_2017\_37890\_68940.jpg

Construction of structures in Oct-2009, photo 2 of 3.

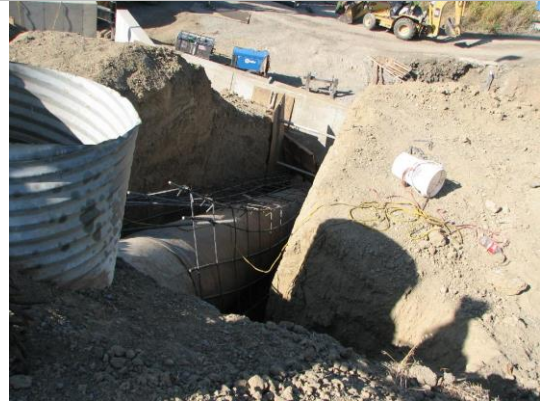
Photo 3 of 3 : UCIP\_SP\_2017\_37890\_68939.jpg

LM Start	4.96	Rating **	M	Issue No.	66 (cont)	
LM End	4.96	Issue Type +	En	Location *	LS	
Category	Supplemental			GPS Latitude/Longitude		
				Start		End
Item	DWR UCIP Field Study			38.516274 °		38.516274 °
				-121.582198 °		-121.582198 °
DWR ID						
Comment Code						
Inspector Comment						
FS_ID:37890						
DS_ID:17880						
EP_NO: 18116						
Repair Type: Non-Urgent						
Crossing Status: Found						
UCIP Comments: Under construction Oct-2009. Need updated photos of completed structure.						
FIELD_STRUCT_DESC: 1 of 4. 54-inch steel pipes through the levee, 12.9 feet below the crown. Pump house on the landward side, siphon breaker on the waterward slope. (Permit No. 18116-2007), (Permit No. 4257).						
FS Date: 10/5/2009

Construction of structures in Oct-2009, photo 3 of 3.

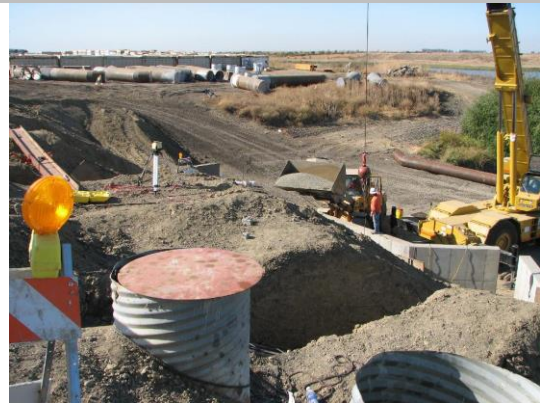
Photo 1 of 3 : UCIP\_SP\_2017\_37891\_68944.jpg

LM Start	4.96	Rating **	M	Issue No.	67
LM End	4.96	Issue Type +	En	Location *	LS
Category	Supplemental			GPS Latitude/Longitude	
				Start	End
Item	DWR UCIP Field Study			38.516225 °	38.516225 °
				-121.582194 °	-121.582194 °
DWR ID					
Comment Code					
Inspector Comment					
FS_ID:37891 DS_ID:17881 EP_NO: 18116 Repair Type: Non-Urgent Crossing Status: Found UCIP Comments: Under construction Oct-2009. Need updated photos of completed structure. FIELD_STRUCT_DESC: 2 of 4. 54-inch steel pipes through the levee, 12.9 feet below the crown. Pump house on the landward side, siphon breaker on the waterward slope. (Permit No. 18116 - 2007), (Permit No. 4257). FS Date: 10/5/2009

Construction of structures in Oct-2009, photo 1 of 3.

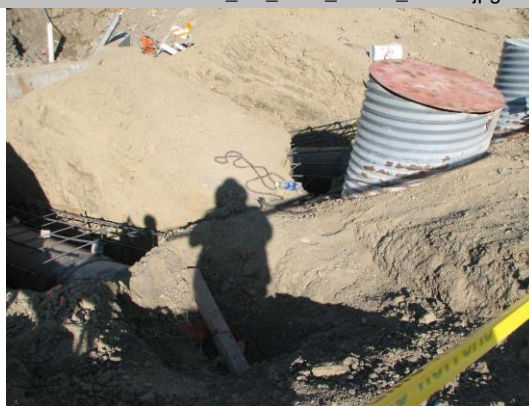
Photo 2 of 3 : UCIP\_SP\_2017\_37891\_68943.jpg

Construction of structures in Oct-2009, photo 2 of 3.

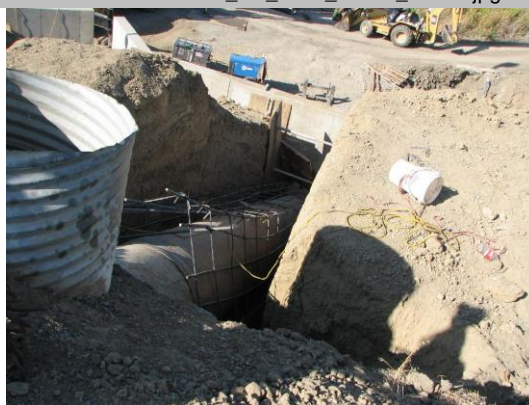
Photo 3 of 3 : UCIP\_SP\_2017\_37891\_68942.jpg

Construction of structures in Oct-2009, photo 3 of 3.

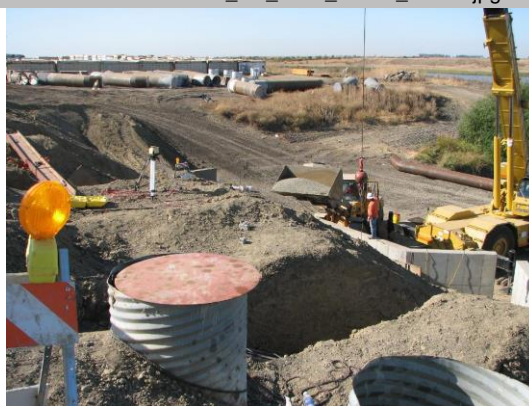
Photo 1 of 3 : UCIP\_SP\_2017\_37892\_68947.jpg

Construction of structures in Oct-2009, photo 1 of 3.

LM Start	4.97	Rating **	M	Issue No.	68 (cont)	
LM End	4.97	Issue Type +	En	Location *	LS	
Category	Supplemental			GPS Latitude/Longitude		
				Start	End	
Item	DWR UCIP Field Study			38.516175 °	38.516175 °	
				-121.582191 °	-121.582191 °	
DWR ID						
Comment Code						
Inspector Comment						
FS_ID:37892						
DS_ID:17882						
EP_NO: 18116						
Repair Type: Non-Urgent						
Crossing Status: Found						
UCIP Comments: Under construction Oct-2009. Need updated photos of completed structure.						
FIELD_STRUCT_DESC: 3 of 4. 54-inch steel pipes through the levee, 12.9 feet below the crown. Pump house on the landward side, siphon breaker on the waterward slope. (Permit No. 18116 - 2007), (Permit No. 4257).						
FS Date: 10/5/2009

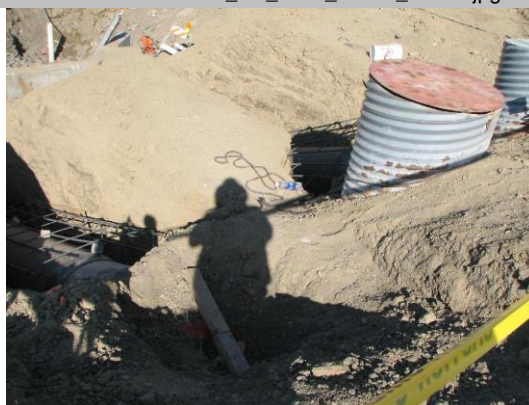
Photo 2 of 3 : UCIP\_SP\_2017\_37892\_68946.jpg

Construction of structures in Oct-2009, photo 2 of 3.

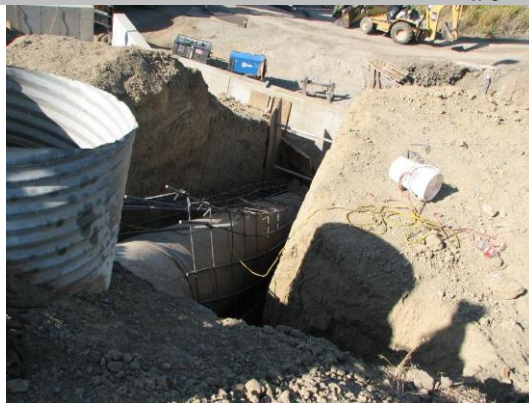
Photo 3 of 3 : UCIP\_SP\_2017\_37892\_68945.jpg

Construction of structures in Oct-2009, photo 3 of 3.

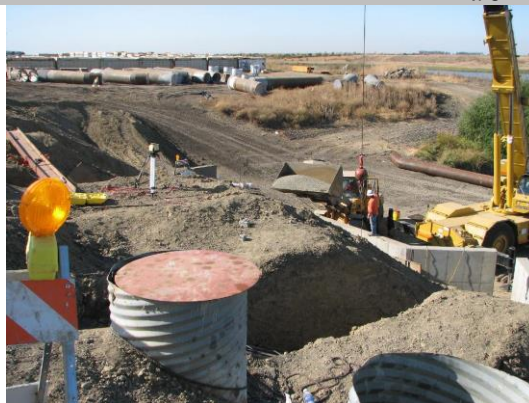
Photo 1 of 3 : UCIP\_SP\_2017\_37894\_68953.jpg

LM Start	4.97	Rating **	M	Issue No.	69
LM End	4.97	Issue Type +	En	Location *	LS
Category	Supplemental			GPS Latitude/Longitude	
				Start	End
Item	DWR UCIP Field Study			38.516141 °	38.516141 °
				-121.582189 °	-121.582189 °
DWR ID					
Comment Code					
Inspector Comment					
FS_ID:37894					
DS_ID:17883					
EP_NO: 18116					
Repair Type: Non-Urgent					
Crossing Status: Found					
UCIP Comments: Under construction Oct-2009. Need updated photos of completed structure.					
FIELD_STRUCT_DESC: 4 of 4. 54-inch steel pipes through the levee, 12.9 feet below the crown. Pump house on the landward side, siphon breaker on the waterward slope. (Permit No. 18116-2007), (Permit No. 4257).					
FS Date: 10/5/2009

Construction of structures in Oct-2009, photo 1 of 3.
